TITLE Potential Health Hazards of Video Display

Terminals.

INSTITUTION National Inst. for Occupational Safety and Health

POTENTIAL HEALTH HAZARDS OF VIDEO DISPLAY TERMINALS

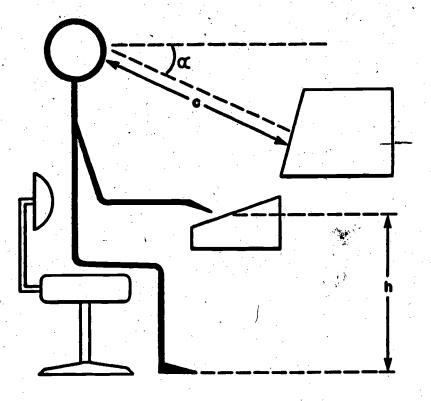
Four factors related to workstation design were examined. These were keyboard height, viewing distance, viewing angle, and chair features. The method of measuring the first three factors is diagrammed in Figure I.

Three basic types of workstations were observed: (1) units in which the VDT screen and keyboard sat on a typewriter stand or other piece of furniture adjacent to an office desk, with home row heights of 775-820 mm. (Although these units had screen and keyboard in separate housings, the operators apparently did not adjust keyboard position in relation to the screen); (2) units in which separate screen and keyboard housings sat on desks with home row heights in the neighborhood of 810 mm; and (3) units in which one-piece VDTs sat on special VDT stands with home row height in the neighborhood of 760 mm (see Table 10).

The estimated viewing distance and viewing angles for male and female operators of median dimensions are summarized in Table 11. Many of the viewing angles were higher than recommended, especially for male operators of greater than median dimensions. Viewing distances were all in the acceptable range (450 to 700 mm).

Where feasible, workstations should be modified so that the keyboard and screen heights are appropriate for the operators. We recommend that where possible, any replacement furniture purchased be designed to allow both keyboard and screen to be within the preferred ranges and adjustable for the preference of

Screen height and position should be adjusted to suit the individual operator. Screen center should normally be 10-20° below the horizontal plane through the operator's eyes, with the top line of the screen below eye level. The viewing distance should normally be between 450-500 mm, and adjustable by the operator without adoption of unusual postures. Viewing distances greater or less than 450-500 mm are acceptable if necessary to accommodate individual operator comfort. It should be noted that these workstation dimensions may pose special visual problems for operators wearing bifocals or those wearing reading glasses ground for reading at 330 mm, and special provisions may be required for these operators.
